1. INTRODUCTION

1.1 Overview of Mir Photo/TV Survey

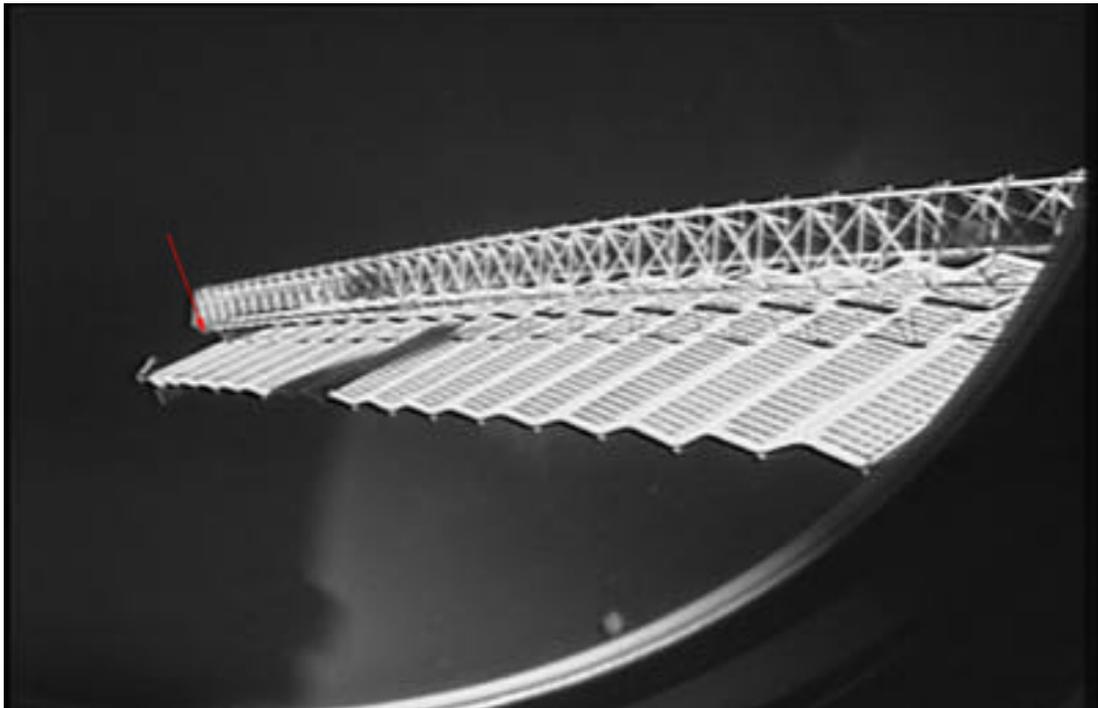
Figure 5-A Typical Digitized Frame of the Cooperative Solar Array

In the video, motion of the array blanket is evident and is correlated to the firings of the PRCs. However, discernible motion of the truss does not occur until the time of soft dock. As the farthest point from the camera, the tip of the truss displayed the lowest resolution on the CSA. The red arrow in figure 5-A denotes the location of the point that was tracked. One thousand frames of the 8 mm video were digitized, and alternate frames were selected for analysis. A point on the tip of the truss was selected at the intersection of two linear structural elements and it was then tracked from frame-to-frame. Selection of the same point in different frames was difficult because of low image resolution. The uncertainty in selecting the same position on the CSA for each frame analyzed was estimated to be +/- one pixel.

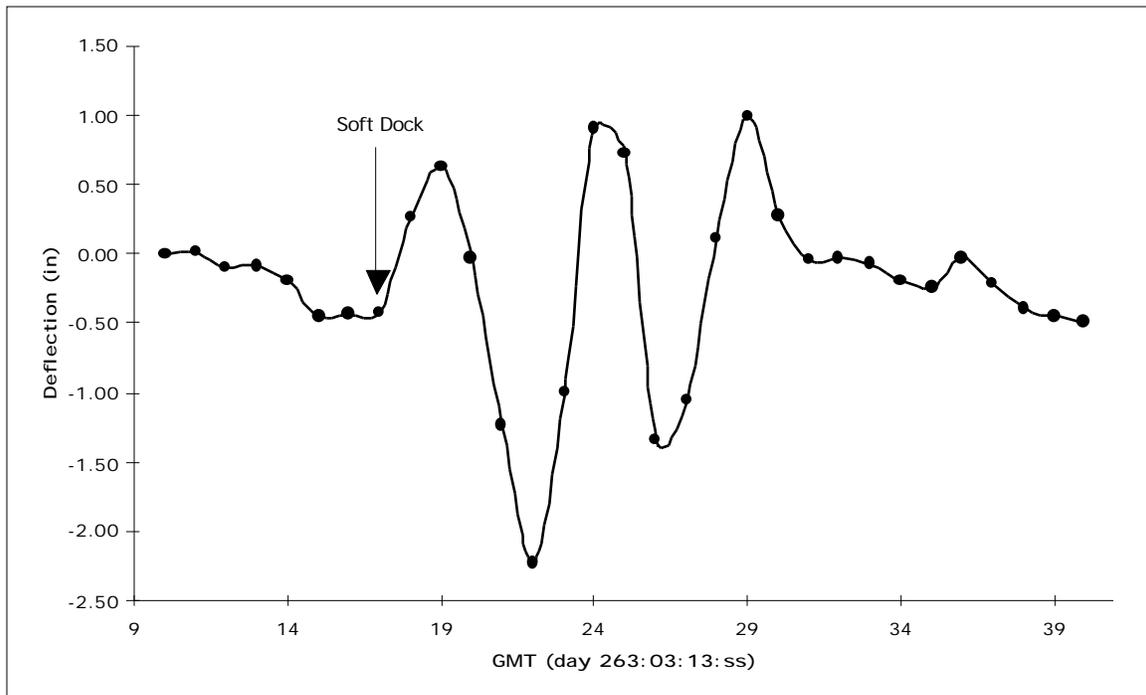
Figure 5-B CSA Truss Deflection vs GMT During Shuttle Docking Sequence

In order to smooth the noise due to fluctuations in placement of data points, a moving average of the deflection data was calculated over 15 frames (1 second). This result is shown in Figure 5-B. An upward trend was seen in the data that may be attributed to a gradual one pixel shift in the placement of the tracking point over the time analyzed. This trend has been removed to generate the curve shown in Figure 5-B.

Approximately 1.5 cycles of motion were detected in the data. The peak-to-peak deflection was approximated from this smoothed curve as 2.8 inches. The lengths of the two cycles were averaged, and the reciprocal of that average provided an estimate of the in-plane oscillation frequency of the tip of the truss. This was calculated to be 0.22 Hz. A natural frequency of 0.28 Hz for the first in-plane mode was derived from the structural model provided by RSC-Energia.

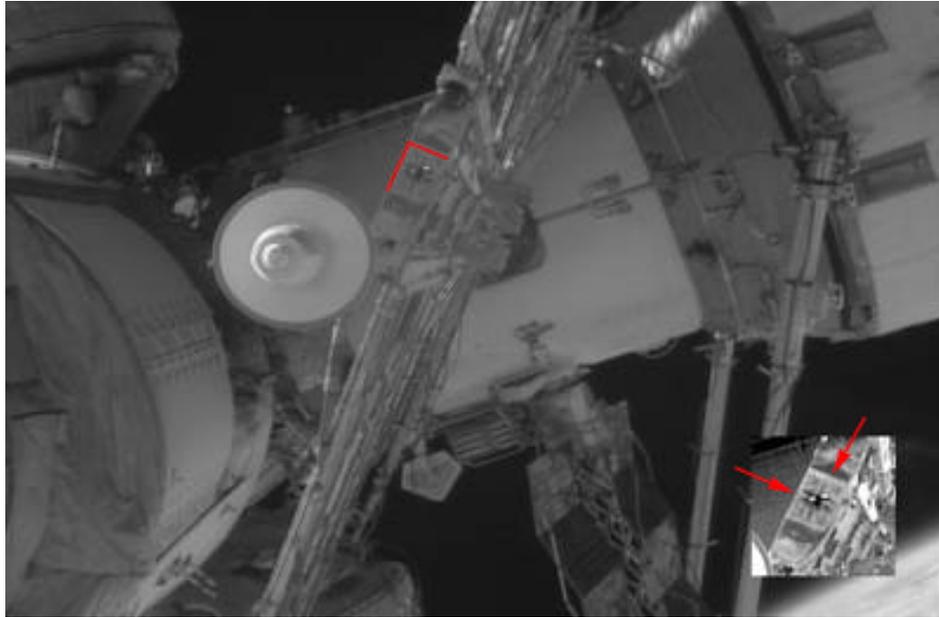
Figure 5-C Base Block Solar Panel #2

During the video survey while the Orbiter was docked to Mir, BB SP#2 was seen oscillating due to an undetermined cause on two separate occasions. Video was acquired of the events, and one event was selected for analysis. Figure 5-C shows a typical digitized video image of BB SP#2 taken with payload bay camera A while the Orbiter and Mir were docked.

An automated line tracking software package was used to track the motion of the array. The red lines in Figure 5-C denote the approximate location of the lines tracked. Two perpendicular lines were tracked, and the intersection of these two lines defined the point to be analyzed. The red lines in Figure 5-C denote the approximate location of the lines tracked. The red arrows in the inset denote the structural features that define the lines. The computer data was augmented with data extracted manually. Scaling was determined using the diameter of the circular antenna on the end of the array visible in Figure 5-C. Six hundred frames of video were digitized, and every other frame was analyzed. A moving average of one second (15 data points) was used to smooth the data for this report. Figures 5-D and 5-E show the in-plane and out-of-plane motion with respect to time. The maximum in-plane deflection is approximately 4.5 inches and the maximum out-of-plane deflection is approximately 5.3 inches. No frequencies of motion were calculated for this array as there is no discernible dominant frequency visible in the data.

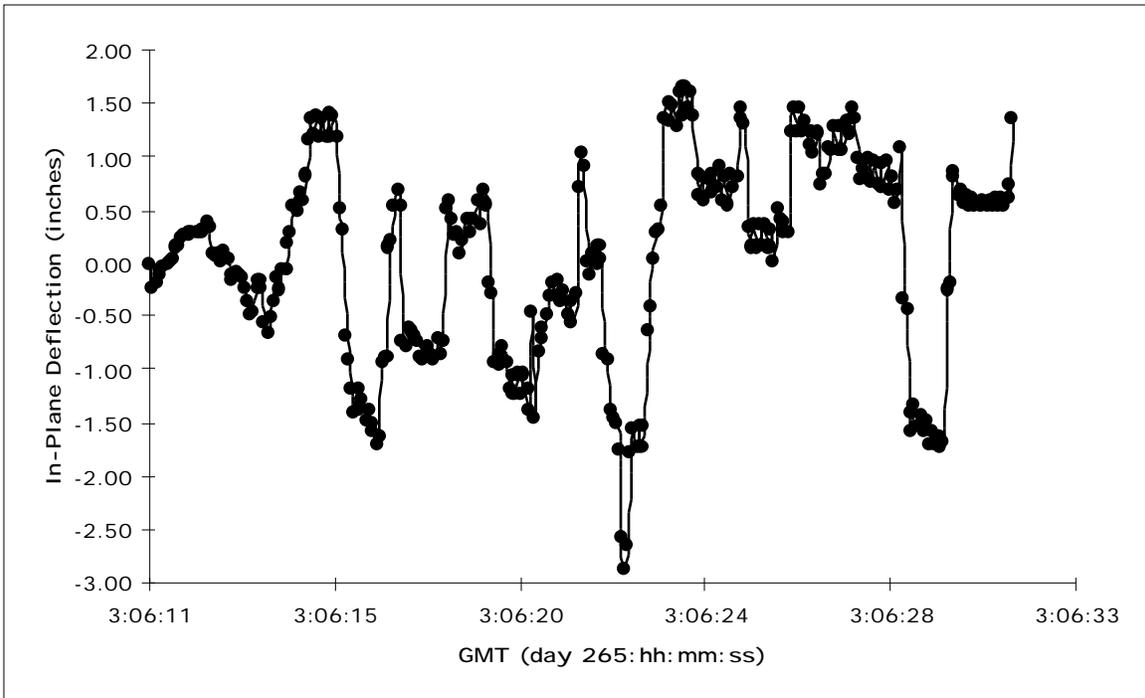
Figure 5-D In-plane Deflection of Base Block SP#2 (Shuttle Docked)

These results may be compared to STS-74 results which reported a maximum amplitude of lateral motion (in-plane) of 5.5 inches. Deflections measured during STS-74 occurred during a time when the array was being rotated. Array rotation was not observed during the STS-79 data acquisition.

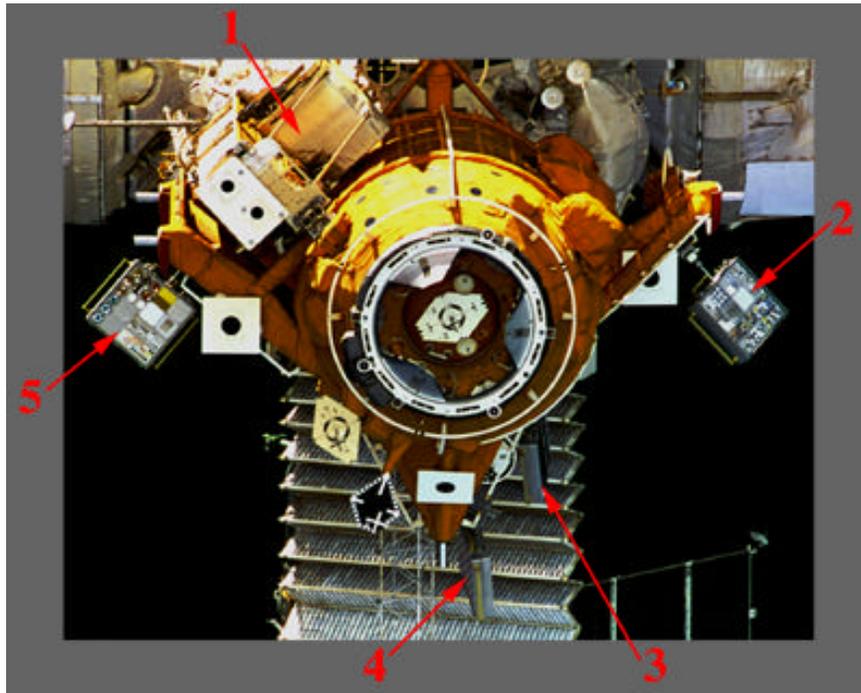
Figure 7-A Docking Module with MEEP Experiments

Figure 7-A is an image of the Docking Module with MEEP experiments and the Reusable Solar Array identified. The image was obtained during Station-keeping at 170 feet using the Nikon camera with 300 mm lens.
